**Flood Control Project Maintenance
Levee Inspections**

Fall 2013 Levee Maintenance Deficiency Summary Report

Brannan Andrus Levee Maintenance District

Levee Inspection Report By Mile - Fall 2013

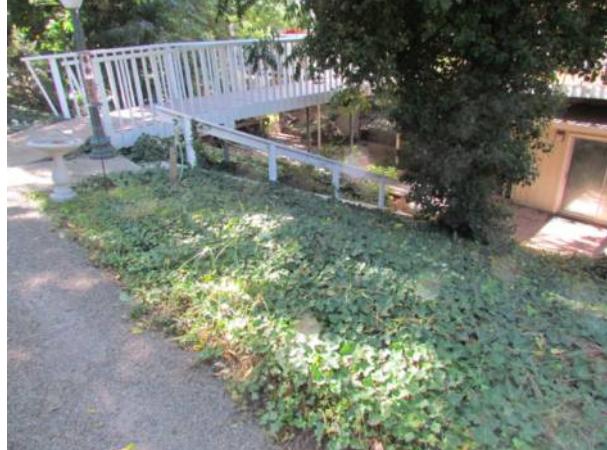
Levee Mile Report Line	8
Start Levee Mile	2.29
End Levee Mile	2.34
Location	Land Side
Category	Earthen Levee
Item	Vegetation
Looking west at ground cover on landside slope.	
richard_f_20130930_527.jpg

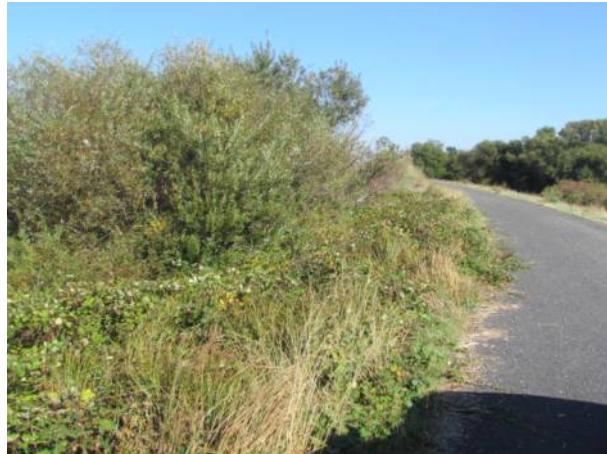
Levee Mile Report Line	32
Start Levee Mile	5.63
End Levee Mile	5.67
Location	Water Side
Category	Earthen Levee
Item	Vegetation
Looking south at dense vegetation on waterside slope.	
richard_f_20130930_521.jpg

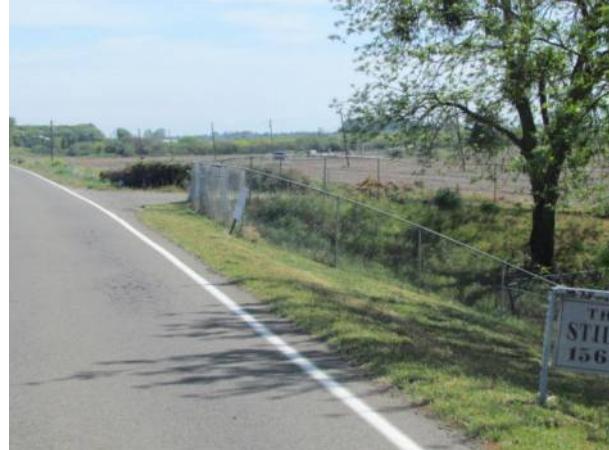
Levee Mile Report Line	1
Start Levee Mile	0.42
End Levee Mile	0.42
Location	Land Side
Category	Earthen Levee
Item	Encroachments
Looking northeast at fence on landward shoulder and slope.	
richard_f_20130930_561.JPG

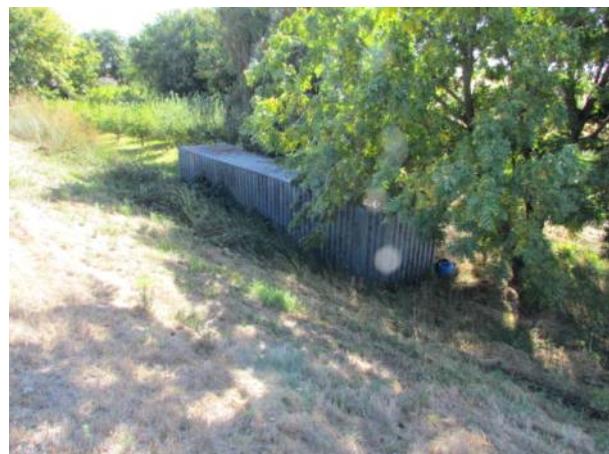
Levee Mile Report Line	2
Start Levee Mile	0.48
End Levee Mile	0.48
Location	Land Side
Category	Earthen Levee
Item	Encroachments
Looking east at storage container at landward toe.	
richard_f_20131021_077.JPG

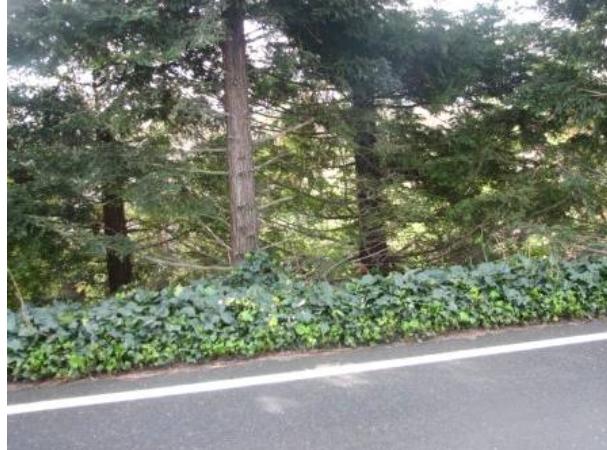
Levee Mile Report Line	6
Start Levee Mile	0.81
End Levee Mile	0.83
Location	Land Side
Category	Earthen Levee
Item	Vegetation
Landscaping on landside slope blocking view of slope from LM .81 to 0.83.	
richard_f_20130930_532.jpg

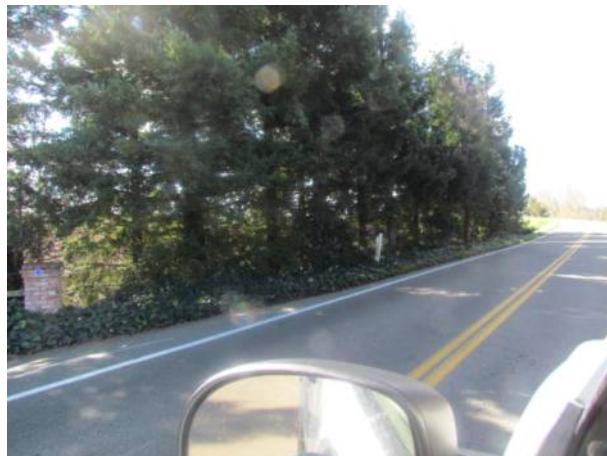
Levee Mile Report Line	6
Start Levee Mile	0.81
End Levee Mile	0.83
Location	Land Side
Category	Earthen Levee
Item	Vegetation
Looking southeast at dense landscaping on landside slope.	
richard_f_20130930_533.jpg

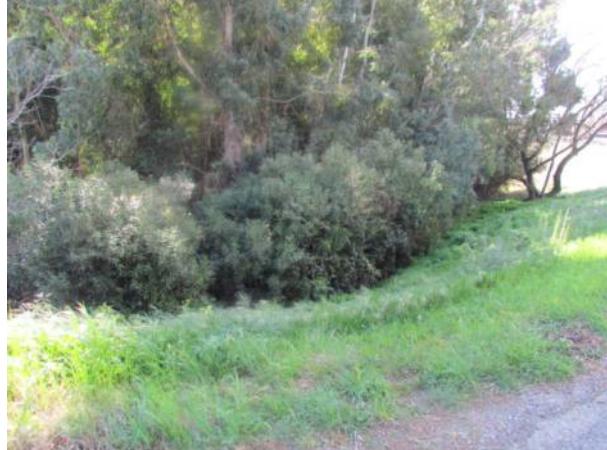
Levee Mile Report Line	8
Start Levee Mile	1.44
End Levee Mile	1.44
Location	Land Side
Category	Earthen Levee
Item	Trim / Thin Trees
Looking southeast at dense trees on landside toe.	
richard_f_20130930_562.jpg

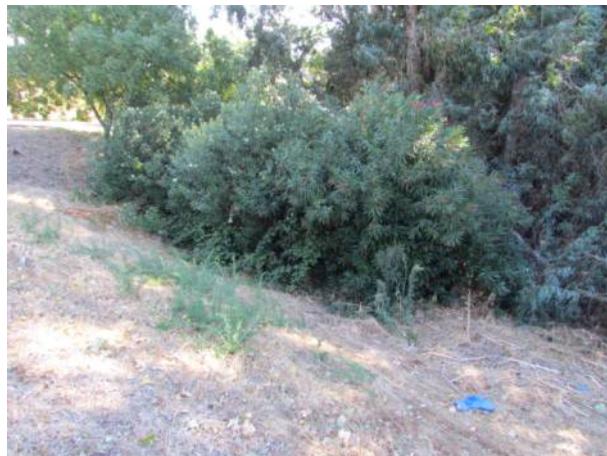
Levee Mile Report Line	8
Start Levee Mile	1.44
End Levee Mile	1.44
Location	Land Side
Category	Earthen Levee
Item	Trim / Thin Trees
Looking northeast at dense vegetation on landward toe.	
richard_f_20131021_079.JPG

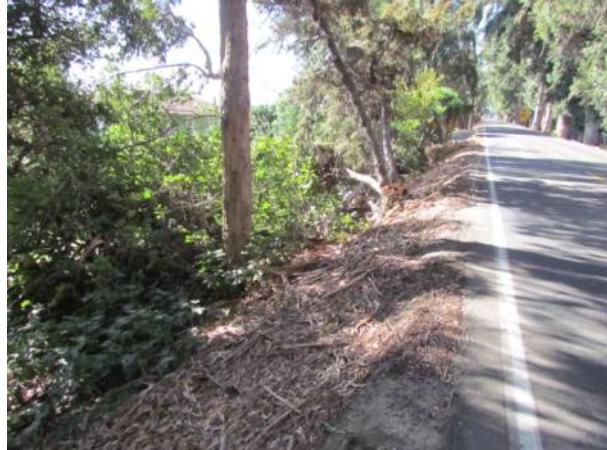
Levee Mile Report Line	12
Start Levee Mile	1.80
End Levee Mile	1.82
Location	Land Side
Category	Earthen Levee
Item	Vegetation
Looking southeast at dense vegetation on landward slope.	
richard_f_20131021_081.JPG

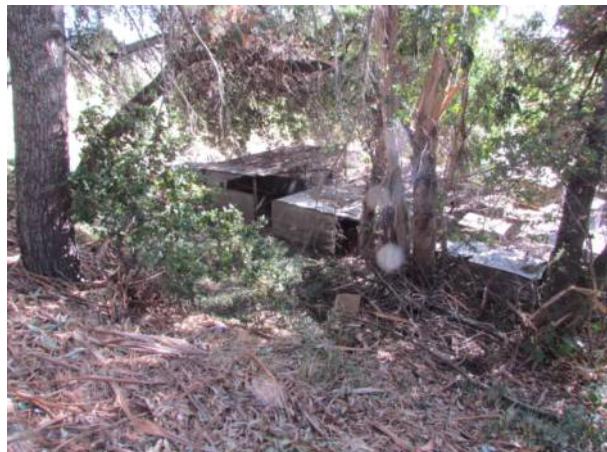
Levee Mile Report Line	13
Start Levee Mile	1.80
End Levee Mile	1.80
Location	Land Side
Category	Earthen Levee
Item	Encroachments
Looking east at animal pens at landward toe.	
richard_f_20131021_082.JPG

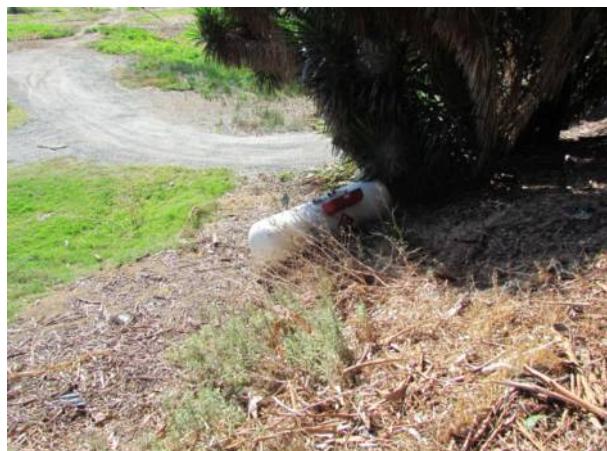
Levee Mile Report Line	15
Start Levee Mile	1.83
End Levee Mile	1.83
Location	Land Side
Category	Earthen Levee
Item	Encroachments
Looking southeast at propane tank on landward slope and toe.	
richard_f_20131021_083.JPG

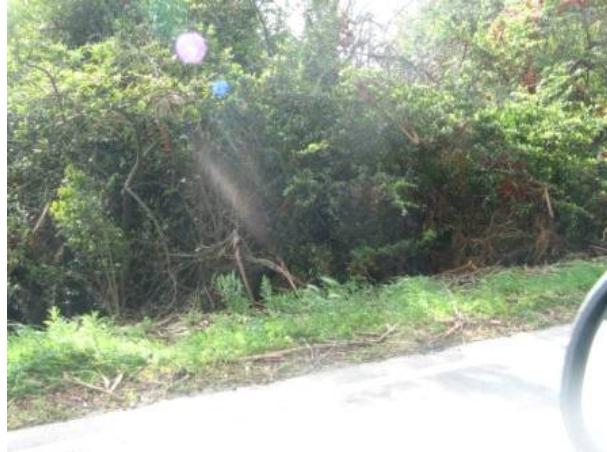
Levee Mile Report Line	18
Start Levee Mile	1.91
End Levee Mile	1.95
Location	Land Side
Category	Earthen Levee
Item	Vegetation
Landscaping on landside slope blocking view of slope from LM 1.91 to 1.95.	
richard_f_20130930_538.jpg

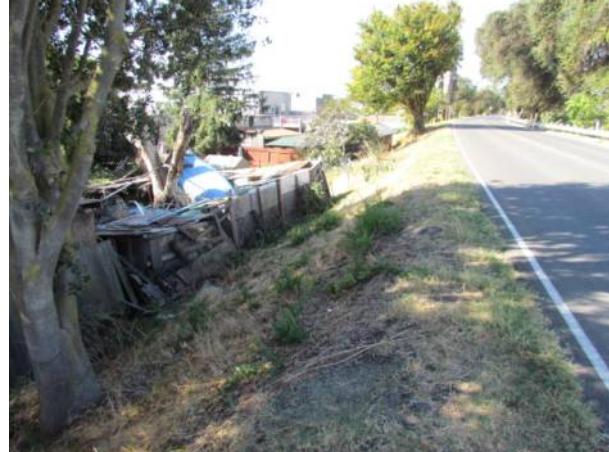
Levee Mile Report Line	23
Start Levee Mile	2.93
End Levee Mile	3.13
Location	Land Side
Category	Earthen Levee
Item	Encroachments
Looking south at urban encroachments on landward slope.	
richard_f_20131021_084.JPG

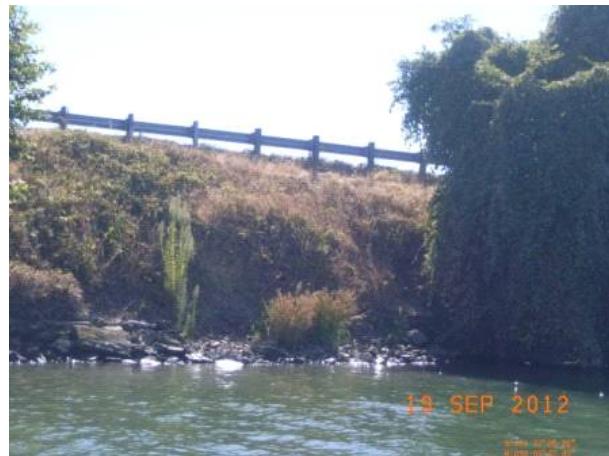
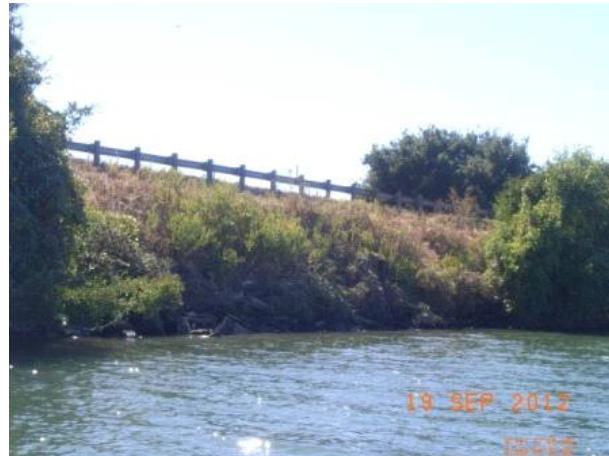
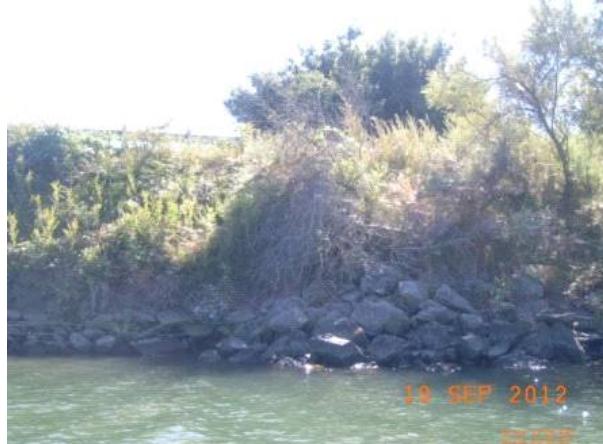
29	3.61	3.72	Supplemental USACE Erosion Survey	WS	U Ma	Inspector Comments: 2008 - Overstepped levee section with pocket erosion. Plans for repair currently in the design phase. 2010 - Very steep slope with slumps, longitudinal cracking, and overturned trees. 2011 - Upgraded to CRITICAL. Sections of vertical slope with highway on top. Heavy vegetation in front of most of the erosion pockets. 2012: No observed change. [2012 Site ID: SAC_16-8_L]	38.162959 °	38.163334 °	20	-121.617323 °	-121.619312 °	Y
30	3.67	3.67	Earthen Levee	Encroachments	LS U Ma	PI : Pipe Inspector Comments: Landowner is repairing a pipe (Permit # 1615) without authorization from CVFPB. The excavation next to ramp is four to five feet deep and three to four feet wide. Landowner needs to ensure the hole is backfilled properly.	38.162855 °	38.162855 °	55	-121.618114 °	-121.618114 °	DWR ID: DWR_NA0002_02_f_2013_55
31	4.01	4.01	Earthen Levee	Trim / Thin Trees	LS M En	T1 : Trim trees to at least five feet above ground level.	38.164470 °	38.164470 °	31	-121.624012 °	-121.624012 °	DWR ID: DWR_NA0002_02_s_2012_31

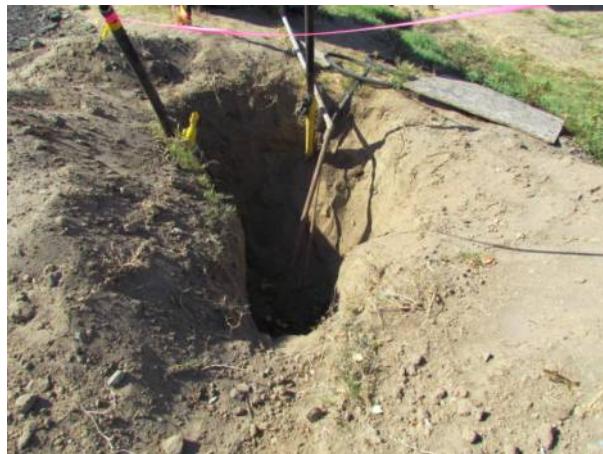
Looking east at excavation on landward slope.

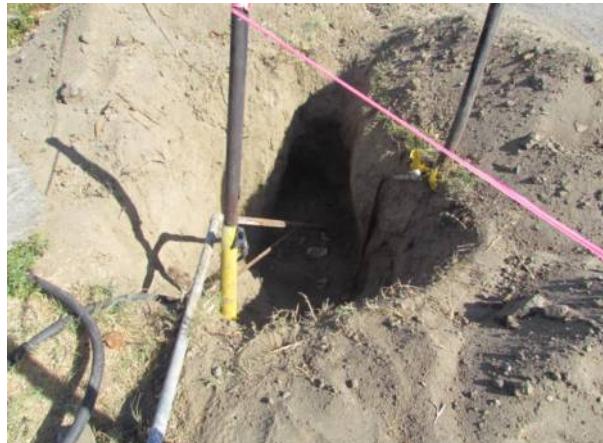
Looking southeast at excavation on landward slope next to ramp.

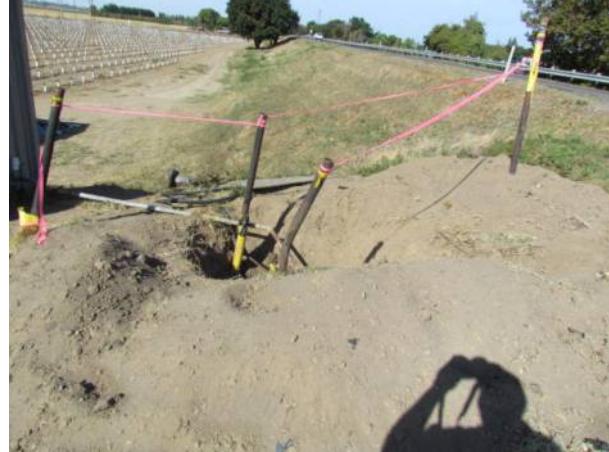
Levee Mile Report Line	30
Start Levee Mile	3.67
End Levee Mile	3.67
Location	Land Side
Category	Earthen Levee
Item	Encroachments
Looking south at excavation on landward slope.	
richard_f_20131021_088.JPG

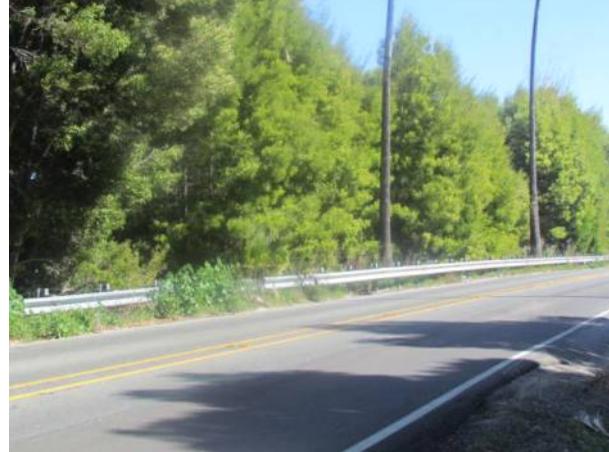
Levee Mile Report Line	35
Start Levee Mile	5.19
End Levee Mile	5.43
Location	Water Side
Category	Earthen Levee
Item	Trim / Thin Trees
Looking southeast at dense trees on landside slope and toe.	
richard_f_20130930_534.jpg

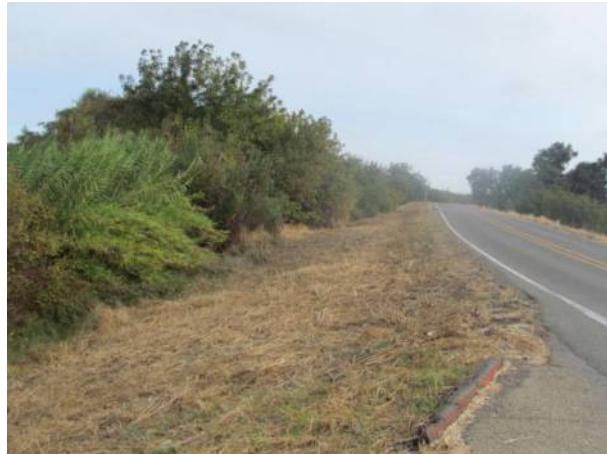
Levee Mile Report Line	38
Start Levee Mile	5.66
End Levee Mile	5.70
Location	Water Side
Category	Earthen Levee
Item	Vegetation
Looking northwest at compliant vegetation on waterside slope.	
richard_f_20130930_537.JPG

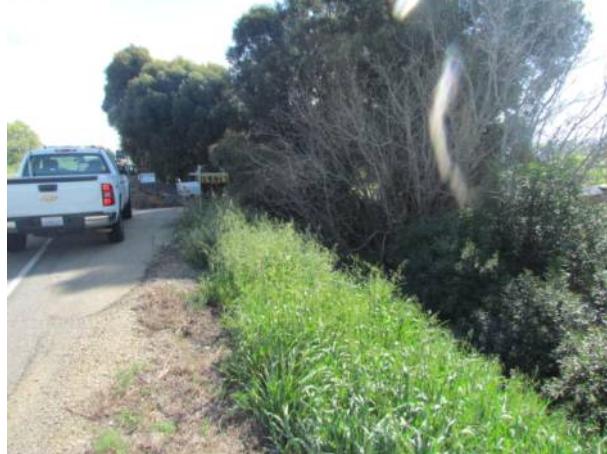
Levee Mile Report Line	44
Start Levee Mile	6.29
End Levee Mile	6.29
Location	Land Side
Category	Earthen Levee
Item	Vegetation
Looking north at dense landscaping on landward slope.	
richard_f_20130930_574.JPG

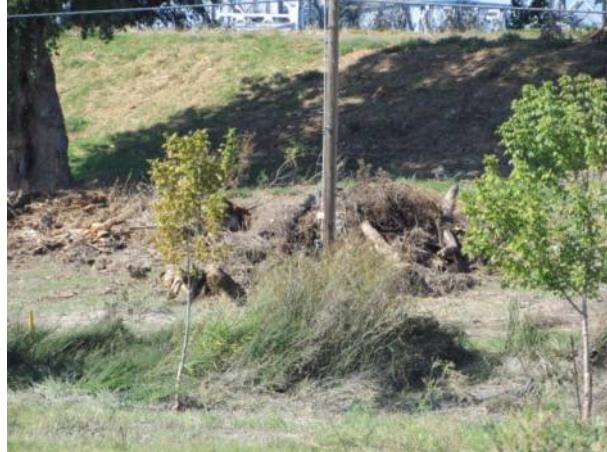
Levee Mile Report Line	49
Start Levee Mile	7.66
End Levee Mile	7.66
Location	Land Side
Category	Earthen Levee
Item	Encroachments
Looking west at prunings on landside toe.	
richard_f_20130930_559.jpg

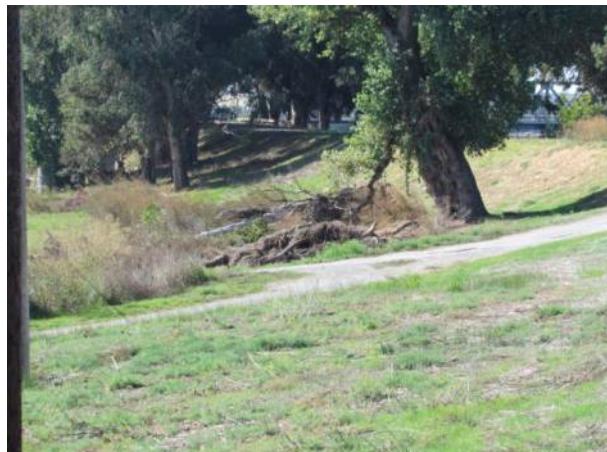
Levee Mile Report Line	49
Start Levee Mile	7.66
End Levee Mile	7.66
Location	Land Side
Category	Earthen Levee
Item	Encroachments
Looking south at prunings on landside toe.	
richard_f_20130930_560.jpg

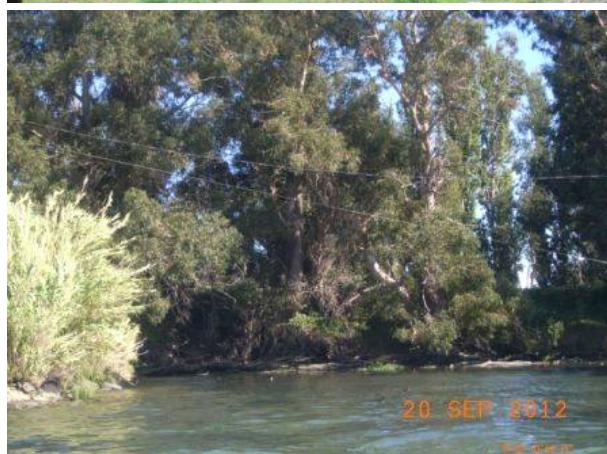
Levee Mile Report Line	50
Start Levee Mile	8.26
End Levee Mile	8.50
Location	Water Side
Category	Supplemental
Item	USACE Erosion Survey
USACE 2012 Photo #1	
USACE2013_SAC_12-1_L_1.jpg

Waterway								Bank	Unit Miles	Inspection Start/End	Inspector
LMR No	Levee Mile		Category	Item	* Location	* Rating	Action/Comment	GPS Latitude/Longitude		Issue No.	
	Start	End						Start	End		
50	8.26	8.50	Supplemental USACE Erosion Survey	WS	M	Ma	Inspector Comments: 2010 - Small inlet area behind a man-built spit. Bank is slumping and could possibly be fixed with maintenance. 2011 - Site continues to worsen. 2012: No observed change. [2012 Site ID: SAC_12-1_L]	38.151867 °	38.148711 °	37	
								-121.682201 °	-121.682790 °	Y	
										DWR ID:	
51	8.35	8.71	Earthen Levee	Trim / Thin Trees	LS	M	T1 : Trim trees to at least five feet above ground level.	38.150112 °	38.144977 °	44	
						Ma		-121.682305 °	-121.683345 °	Y	
								DWR ID: DWR_NA0002_02_s_2012_44			
52	8.42	8.42	Earthen Levee	Encroachments	WS	M	TR : Tree or limb	38.149000 °	38.149000 °	57	
						Ma	Inspector Comments: Tree limbs on waterward slope.	-121.682479 °	-121.682479 °

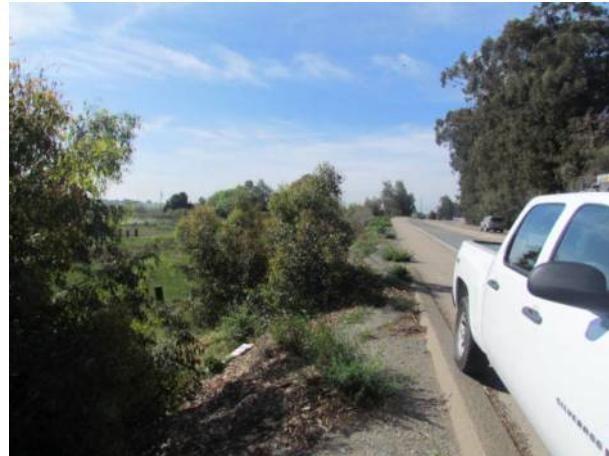
Levee Mile Report Line	54
Start Levee Mile	8.68
End Levee Mile	8.89
Location	Land Side
Category	Earthen Levee
Item	Trim / Thin Trees
Looking south at trees on landward slope.	
richard_f_20130930_573.JPG

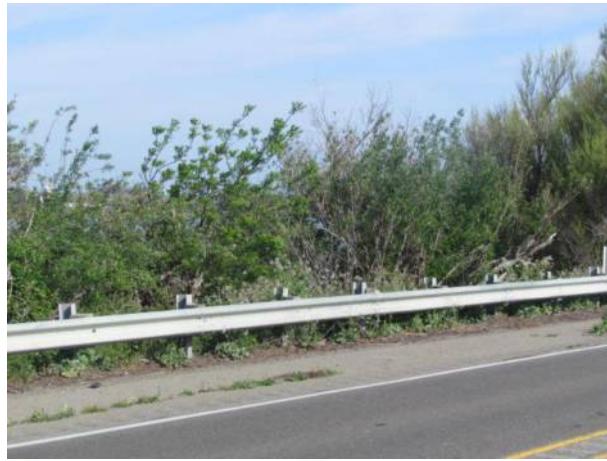
Levee Mile Report Line	58
Start Levee Mile	9.68
End Levee Mile	9.74
Location	Water Side
Category	Earthen Levee
Item	Vegetation

Looking west at dense vegetation on waterward shoulder and slope.
